Research
Note
FPL-0240

Performance of Wood in a Do-It-Yourself Solar Collector¹

By
G.E. SHERWOOD
and
W.A. GATZ
Forest Products Laboratory:
Forest Service
U.S. Department of Agriculture

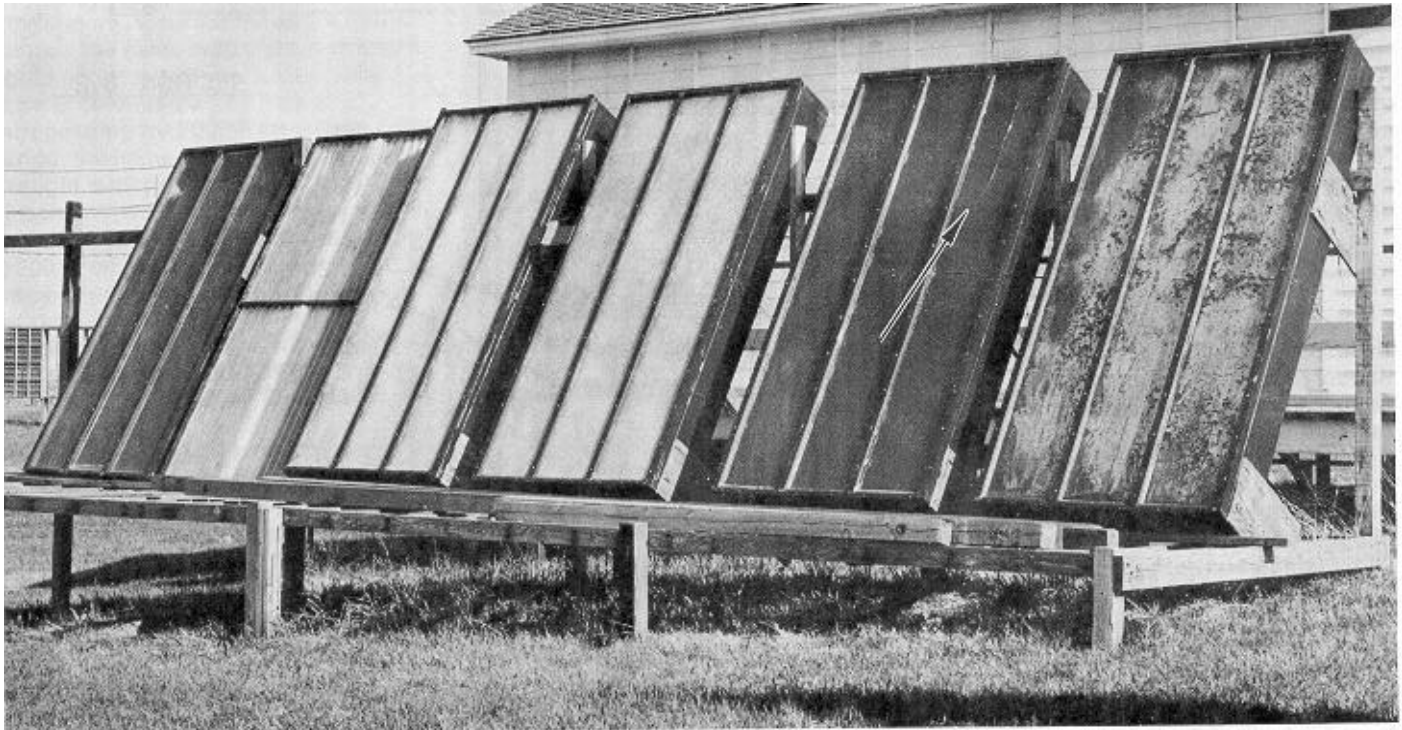
(M 147 004-9)

Figure 3.—All six solar collector panels mounted at the exposure site.

The mottling in the panel at the far right is the result of the black lacquer peeling off the metal collector plate and settling to the bottom of the panel.

In the second panel from the right, the arrow shows the crack in the glass of Panel 3.

There appeared to be no major difference in the radiant heat collection ability of the two types of paint. The flat black paint used performed well with no peeling, blistering, or other signs of deterioration. The lacquer used did peel from the metal collector (fig. 3), and slightly lower temperatures were observed in the collector after peeling.

produced slightly higher maximum temperatures than did glass. The flat fiberglass used in combination with corrugated plastic performed as well as two sheets of flat glass. A large crack occurred in one of the sheets of glass (fig. 3).

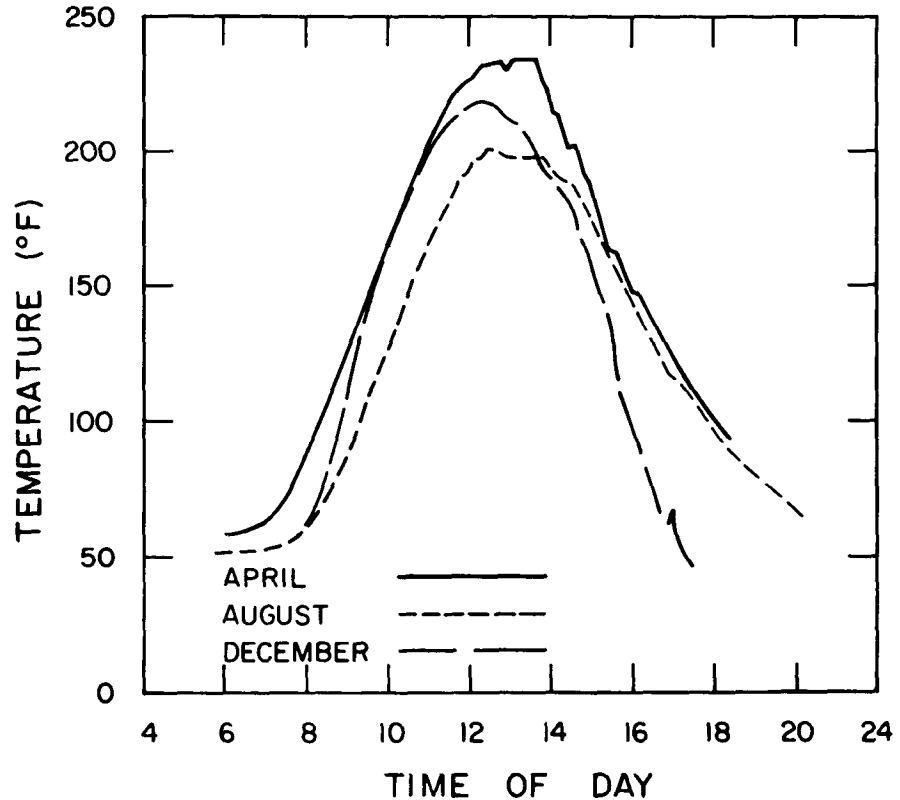
(M 148 282)

200° F on the selected sunny day in August, and only one panel (No. 3) had temperatures exceeding 200° F on the selected sunny day in December. The highest temperatures were in Panel 3, which had temperatures above 200° F on 123 days or about one-third of the days of a year.

As stated in the "Background" section, permanent reduction in strength of wood due to 1 year of exposure to a temperature of 200° F would be about 13 percent. In Panel 3, with such temperatures occurring for about 4 hours per day on about one-

third of the days of the year, the 13 percent reduction would occur in about 18 years. However, if 250° F occurred for about 2 hours per day, the 13 percent strength reduction would be estimated in 9 years. During the time this high temperature is maintained, a 40 percent immediate reduction in strength would also be expected to occur. It should be recognized that the above effects assume stagnation conditions in the collector. Under normal operating conditions, temperatures should be much lower.

Figure 4.—Temperatures cycles in Panel 3 for a selected sunny day in each of three months.

Spontaneous ignition has occurred in wood heated above 212° F for long times, so the collector panels tested should not be maintained at stagnation conditions for long times. Under operating conditions, temperatures should be kept below 212° F.

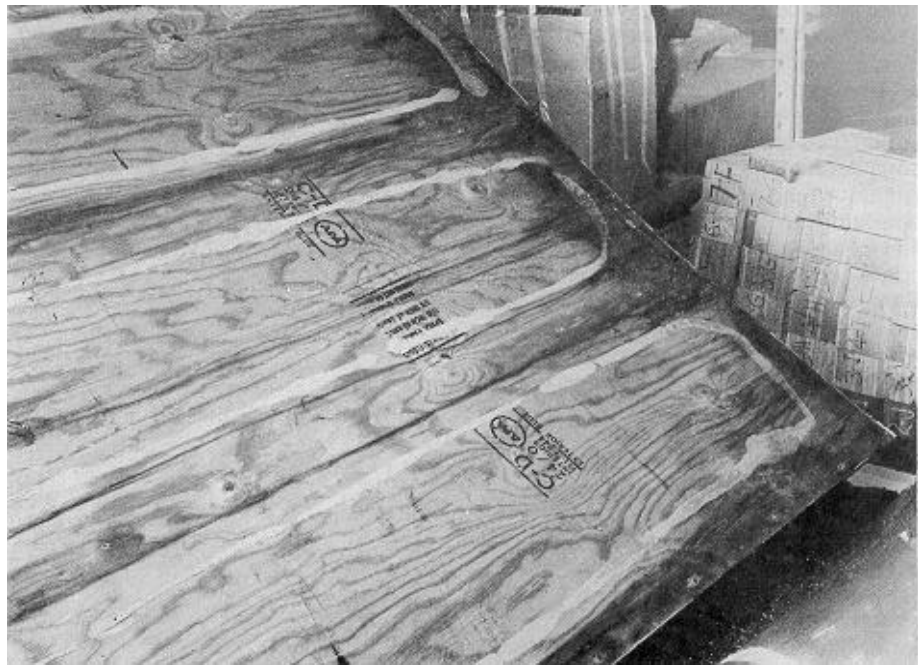
(M 147 058-1)

Solid wood in all of the collectors showed no visible signs of char or degradation of any type. Plywood on the backs of Panels 1, 2, 3, and 4 was insulated from the main cavity, and temperatures in Panels 5 and 6 were not high enough to have much effect on the plywood. However, plywood in all the panels was affected by condensation. Inside faces were water stained (fig. 5), and some delamination occurred. Screws used to attach the plywood were quite corroded. C-D grade plywood with an exterior glue was used as specified in the plans, but should not be used for continuous outdoor exposure. An exterior grade plywood should solve the delamination problem but moisture could eventually cause decay and the corroded screws would lose much of their holding power.

Figure 5.—Plywood back of a collector panel badly water stained due to condensation.

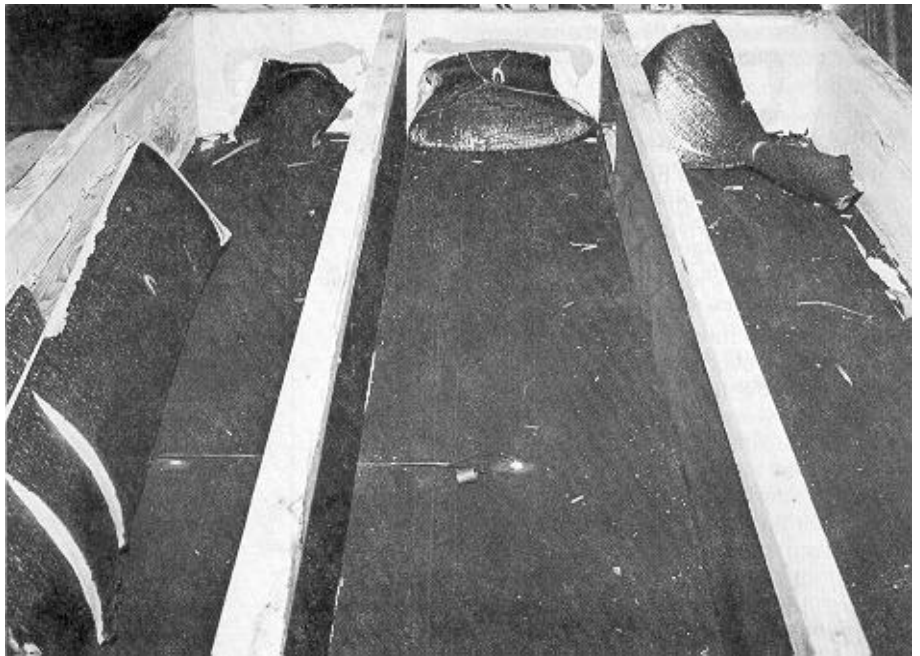
(M 147 057-6)

The only insulation used was an extruded polystyrene, which the manufacturer recommends not be used where temperature exceeds 160° F. At temperatures over 200° F, the foam distorted severely (fig. 6). The least distortion occurred adjacent to the plywood because the average temperature was lower than where the 2- by 10- framing insulated the foam from outdoor temperature.

Figure 6.—Rigid insulation severely distorted due to temperatures higher than manufacturer's recommendation.

Under normal operating conditions, temperature in the collectors may not be high enough to damage the foam; however, if stagnation conditions are expected for even short periods, another type of insulation should be considered.
