# Remilling of salvaged wood siding coated with lead-based paint. Part 2. Wood product yield

## Abstract

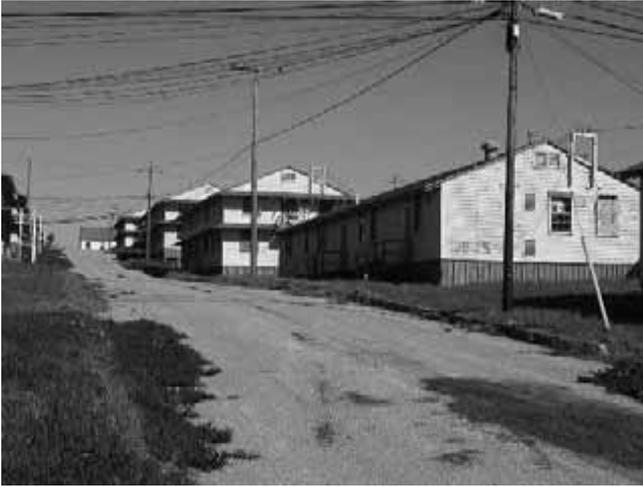
Figure 1. — Single-story barrack in Fort Ord from which LBP siding was obtained.

The installed siding was thoroughly inspected and photographed to document external building conditions prior to deconstruction. This on-site inspection showed heavy paint accumulations after 50 or more years of active service life. Siding pieces from each building were given a unique identification number, which indicated exposure – north (N), east (E), south (S), or west (W) – as well as vertical location on each wall. Some siding pieces with failed paint were noticeably checked and had photo-oxidative surface erosion. Removal of siding was coordinated by FORA and the U.S. Army Construction Engineering Research Laboratory (CERL). Siding was bundled and transported full length to the Forest Products Laboratory (FPL).

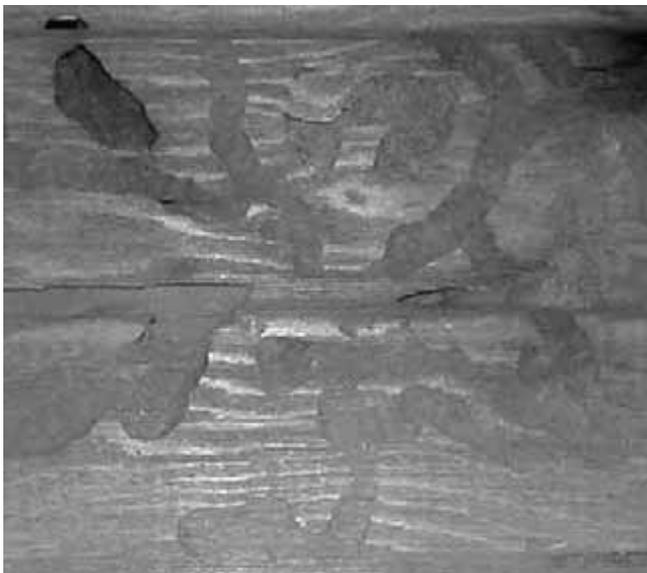
Several bevel siding and V-groove paneling pieces were rejected because of insect damage not observed until after remilling. Exposed gallery tunnels (Fig. 4) combined with an adult insect prothorax showed that this internal wood damage was caused by metallic wood borers (*Buprestis aurulenta*). Additional losses (Table 4) reflect adjustment measures to account for end-split meeting a C & Btr grade of millwork under WCLIB rules. Of the total linear footage processed, 29.7 percent of the remanufactured Douglas-fir siding material met the criteria for vertical grain millwork.

Figure 4. — Insect damage exposed after siding was remilled.

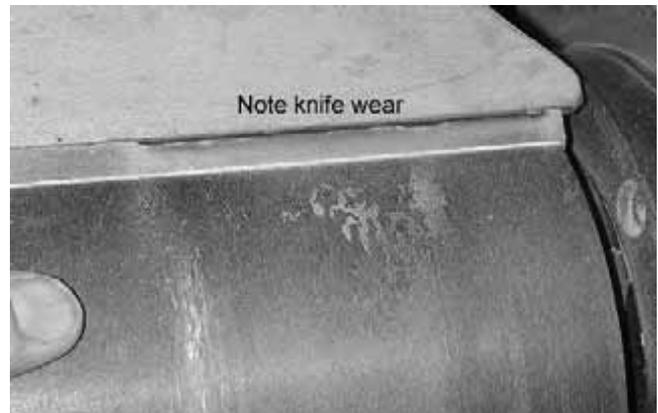
The edges of the high-speed steel (HSS) knives dulled rapidly (Fig. 5), which indicates that this type of knife would need to be sharpened or replaced frequently when machining LBP surfaces. Degradation in surface quality was observed after freshly sharpened HSS knife blades had processed only about 275 m (900 ft) of painted siding. Interruptions in processing to sharpen or replace knives after such a short run would seriously hamper production.

Figure 5. — Condition of conventional high-speed steel knife blade after processing approximately 900 lf of Douglas-fir LBP siding material.

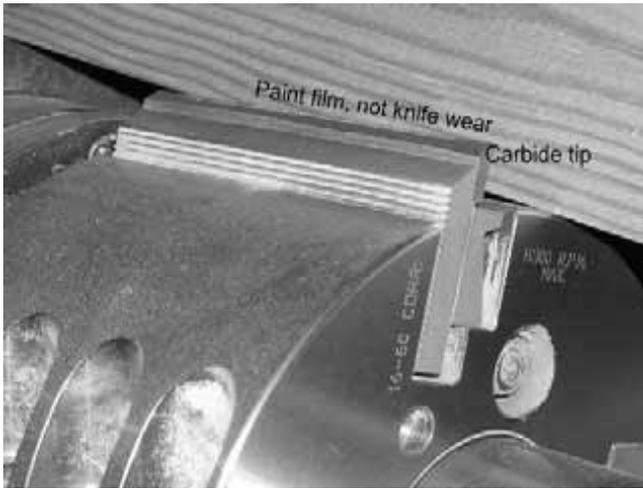
Although only 999 m (3,277 lf) of siding remained to be processed, carbide-tipped knives were purchased to see if more material could be processed without surface degradation than with the HSS knives. All of the remaining siding was remilled without degrade in surface quality. The condition of the carbide-bonded knives (Fig. 6) suggests that much more material could have been processed with these knives compared with HSS knives before milled surface quality would have been discernibly affected.

Figure 6. — Condition of carbide-bonded knife after processing more than 3,000 lf of knotty southern pine LBP siding material.
