# UNDERSTANDING EXTRACTIVE BLEED

## WOOD EXTRACTIVES: DISTRIBUTION, PROPERTIES, AND CLASSES

Joint Coatings/Forest Products Committee;  
Extractives Task Force

# COATINGS TECH

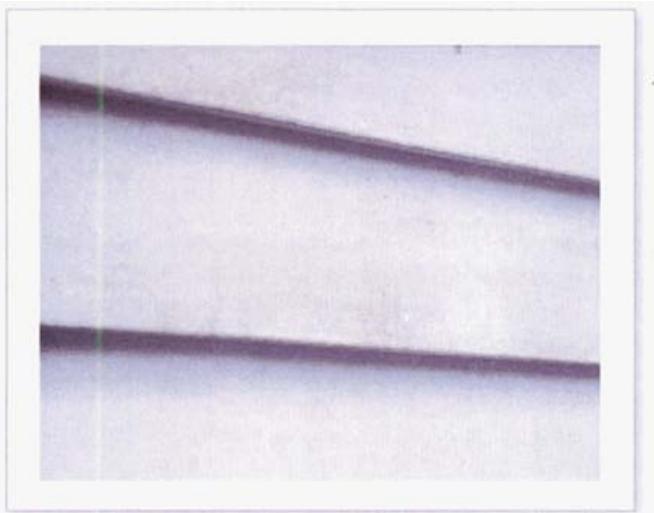
Figure 1 - Diffused extractive bleed.

- Diffused discoloration of paint (Figure 1) typically results from penetration of the paint film by water or water vapor. This diffused discoloration usually occurs in the first few cycles of wetting or high humidity after paint application and can be attributed to a porous or thin paint coat that is insufficient to prevent water penetration. The water present as the carrier in waterborne finishes can also cause diffused discoloration. In these cases, discoloration is evident at the time of coating application, even before the coating has dried. Traditional stain-blocking primers were formulated with oil alkyds, which have proven to be best in preventing extractive bleed when applied as the first or primer coat. Recently, coating manufacturers have formulated waterborne stain-blocking primers to comply with regulations restricting solvents in paint. The waterborne systems do not work as well as traditional oil-alkyd-borne formulations, but manufacturers continue to improve them.

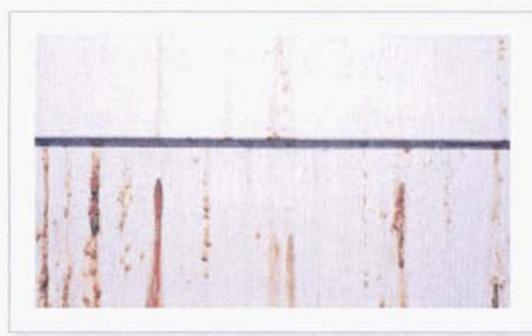
- Run-down or streaked type of extractive bleed (Figure 2) indicates that water has gained access to the back side of the siding. This can be caused by washing the wood with high-pressure washers, condensation of water vapor, leaks from improper flashing or building paper use, wind-blown rain behind the siding, or open joints in the wall that permit rainwater intrusion. In the case of siding that has not been end-primed after having been cut to fit around door and window openings, rain can cause this run-down form of extractive bleed. Rainwater easily soaks into the unsealed end grain of the siding where it dissolves extractives in the wood (Figure 3). These forms of stain are best prevented with good building practices.

**Figure 2** —Run-down extractive bleed.

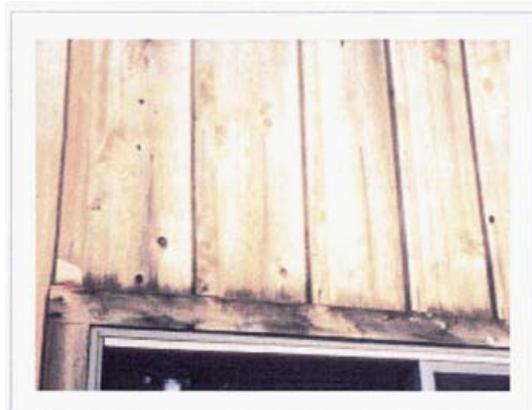
**Figure 3** —Extractive bleed from end-grain adsorption of water. Note the fasteners have also caused iron staining.

- Seal siding and trim end cuts during installation with a water-repellent preservative or oil-alkyd primer. (Sealing the end grain will retard the absorption of water for years.)

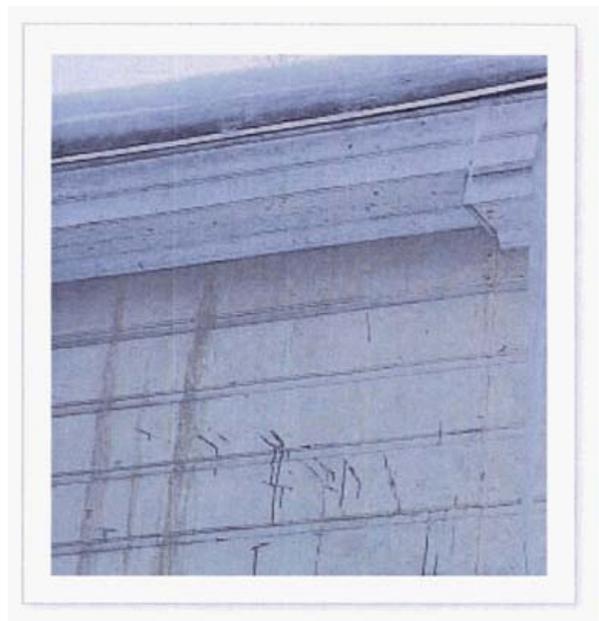
- Ice dam on roofs can cause water to overwhelm drains and gutters and flow behind rake boards, soffits, fascia, and siding causing extractive bleed (Figure 4).

**Figure 4** - Ice dam on roof and gutter. The resulting water intrusion into the wall and behind the siding often causes run-down extractive bleed.

- Design structures to avoid overwhelming gutter systems, creating ice dams on roofs, or any other feature that allows water to flow behind siding and trim.

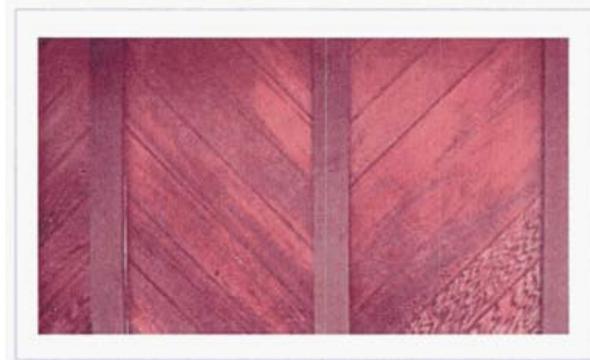
- Unfinished wood that is allowed to weather naturally may take on various colors from extractives migrating to the surface (Figure 5).
- Initial MC of wood at the time of installation can contribute to extractive discoloration of coatings if the builder fails to acclimate the wood before it is installed. Unfortunately,

Figure 5 - Uneven extractive bleed on siding.

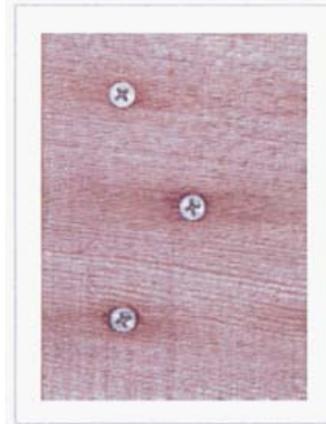
- Nails and other fasteners damage wood, and water absorbed into these damaged areas may result in localized extractive bleed near the fasteners (Figure 6). This type of extractive bleed is minor and usually disappears within a few weeks. It should not be confused with blue-black iron stain, which is caused by the chemical reaction between iron leaching from low-quality fasteners and tannins in the wood (Figure 7). Tannins are one of many WSE and are found in high concentrations in several commonly used wood species (redwood, many cedars, oak). Minute amounts of iron cause this type of discoloration, and it is extremely difficult to remediate. Although the unsightly blue-black stain can be neutralized with an aqueous oxalic acid solution, it will reappear if the source of iron—typically an inappropriate fastener—is not removed. If improper fasteners were

Figure 6—Extractive bleed around stainless steel fasteners.

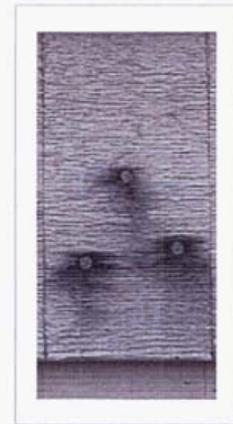
Figure 7—Iron stain around electro-plate galvanized fasteners.

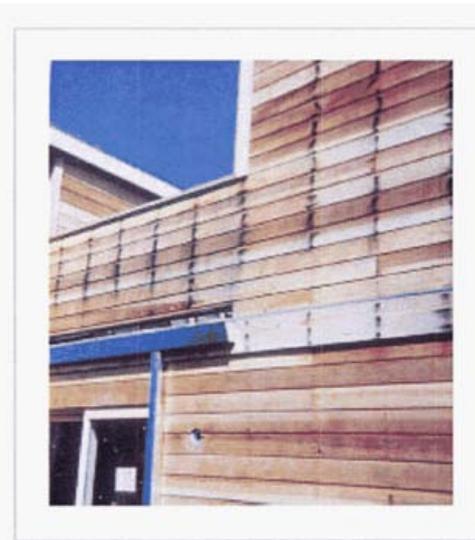
Figure 8—Iron stain on newly constructed home. The intent of the owner was to have a natural finish (lightly pigmented semitransparent stain) on the siding. To correct this, the siding will need to be replaced.

used to fasten siding to a structure, fixing this is almost impossible (Figure 8). The only long-term solution is to replace the siding—an expensive fix caused by careless selection of fasteners. Use of stainless steel fasteners or consulting with the wood supplier for recommendations regarding fastener choice will help avoid this problem.

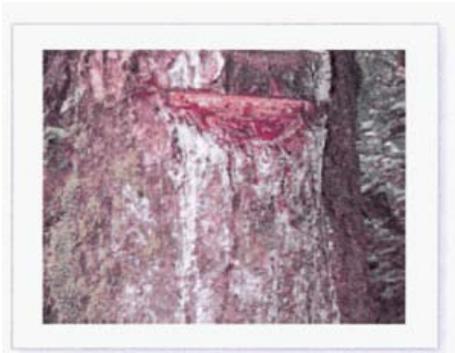
Figure 9-Pitch bleed from a cut on a tree.

of the wood and is particularly common over knots. Pitch and other resins are a defense mechanism that a tree uses to protect itself from harmful pathogens and insects following injury. When a tree's bark is damaged, pitch flows into these areas to protect the wound (Figure 9). Pitch also exists as a normal part of the wood of pines (*Pinus* spp.), spruces (*Picea* spp.), larches (*Larix* spp.), and Douglas-firs (*Pseudotsuga* spp.), and can be found in specialized **wound** structures called pitch pockets in the wood of most softwood species. Chemically speaking pitch is a solution of natural rosins and turpentine. Although pitch is an SSE, it exudes from wood by bulk flow without solvent extraction.

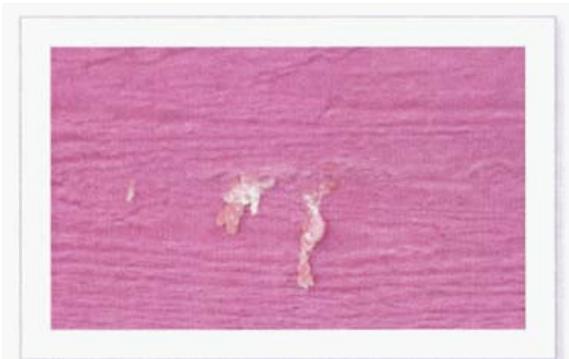
Figure 10-localized pitch bleed.

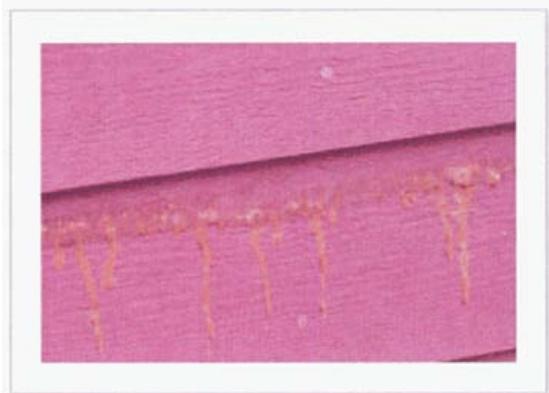
Figure 11 - Large pitch pocket or seam.

If wood exhibits pitch bleed, there are several ways to remove the pitch depending on how fluid it is. If the pitch has not hardened (that is, if it still contains enough turpentine), it can be removed by dissolving it with turpentine or mineral spirits. Once it has hardened, it can be removed fairly easily with a putty knife, paint scraper, or sandpaper. If the pitch is still soft, such procedures smear it over the surface of the wood and paint. If the pitch cannot be easily dissolved with mineral spirits, it is probably best to let it harden and scrape it off. It may be possible to set small amounts of pitch by heating the wood with a heat gun, but this probably will not work for large pitch pockets, such as shown in Figure 11, or those located deep in the wood.
