# Remilling of salvaged wood siding coated with lead-based paint. Part 2. Wood product yield

## Abstract

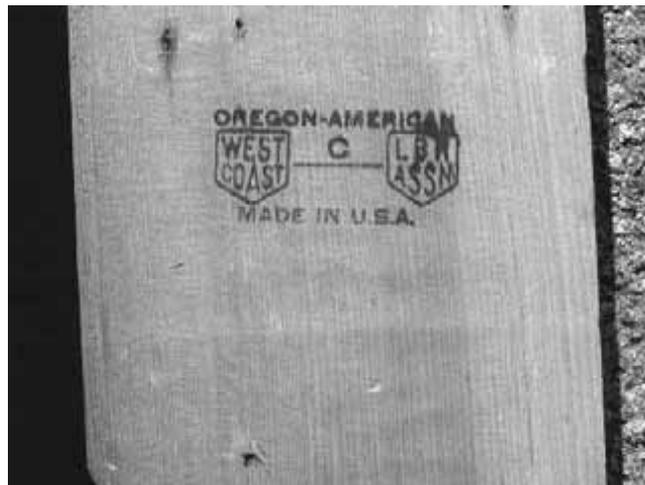
Figure 2. — Grade stamp marking observed on several pieces of salvaged Fort Ord siding.

Inspection of the LBP coated wood siding yielded much information about the potential to produce value-added wood products. The first visual assessment of all pieces indicated that the Fort Ord siding was manufactured from high quality Douglas-fir. This was confirmed by the discovery of a few isolated grade stamps (Fig. 2). Most pieces of siding had one clear face with few knots and were finely textured (30 or more growth rings per inch). We also observed that a substantial proportion (30%) of the salvaged siding was vertical grain, which is highly desired for finished millwork markets.
