General  
Technical  
Report  
FPL-IMP-GTR-2

# Quality Drying of Hardwood Lumber Guidebook-Checklist

## Guidebook-Checklist

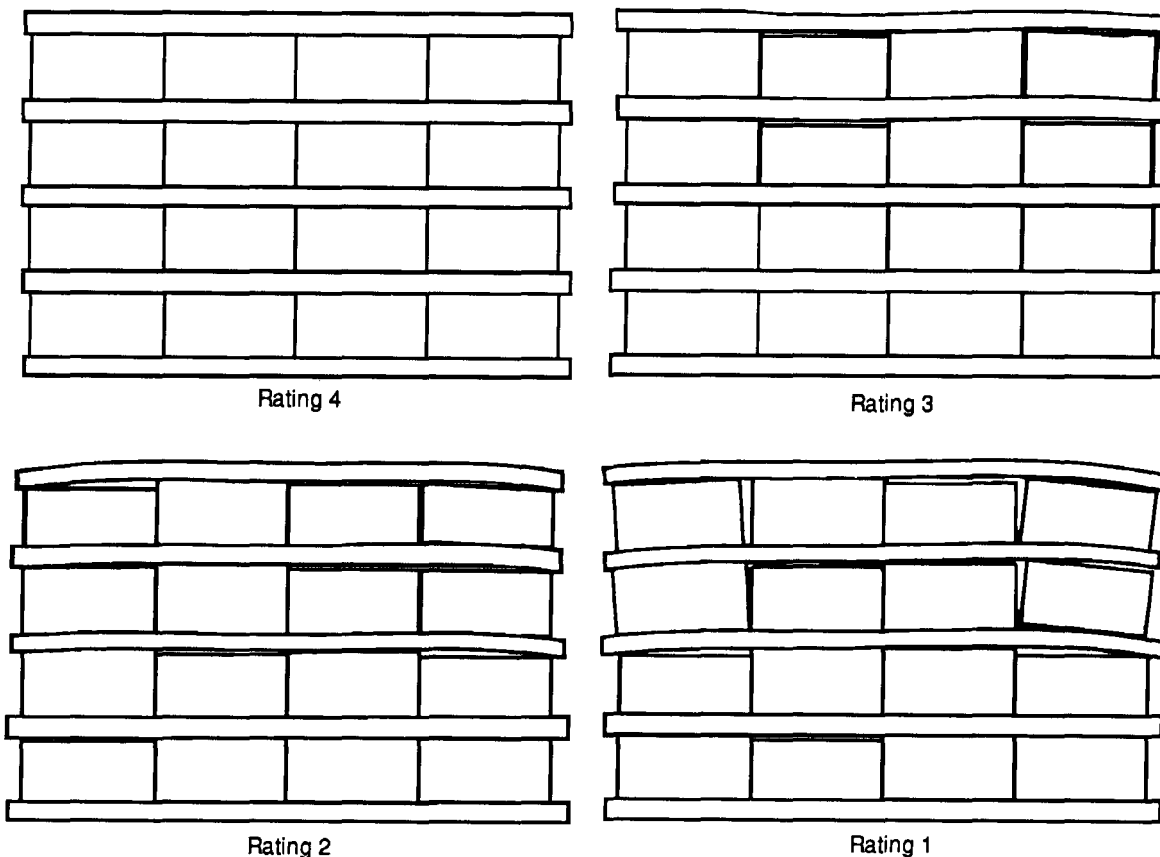
Look at the ends of 15 packages of green lumber. All the boards should appear the same thickness with the stickers straight and touching all boards. Note gaps where thin boards are not restrained by the stickers. Also look for stickers bent over thicker boards. Figure 1 illustrates how to evaluate thickness variation.

Figure 1. Evaluating lumber thickness variation.

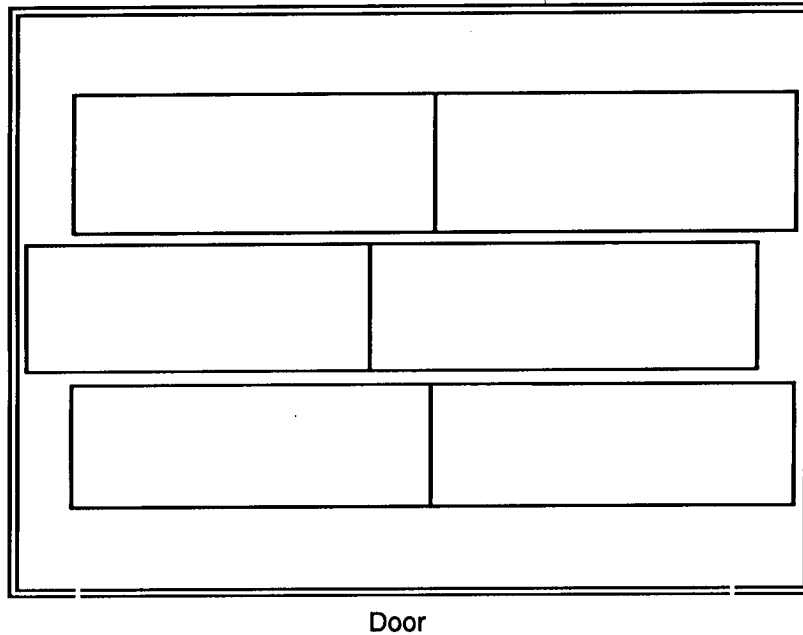
Careful placement of packages and baffles is particularly important in package-loaded kilns to prevent short circuiting of airflow. Short circuiting is more critical in a package-loaded kiln than in track-loaded kilns because of the generally longer distance air must travel from the entering-air to the leaving-air side of the load. In general, the greater the capacity of package loaded kilns, the more difficult it is to prevent short circuiting. When loading a package kiln, the initial back row of packages *should* be placed tight against *one* wall. The second row should be side shifted so it is tight against the opposite wall. The placement of packages should be alternated from one wall to the other until all rows have been loaded (Fig. 3). This will leave a minimum of air space along either side wall for short circuiting of air.

*Figure 3. Top view of proper package placement in a package kiln.*
