Effect of drilled holes on the bending strength of large dimension Douglas-fir lumber

Abstract

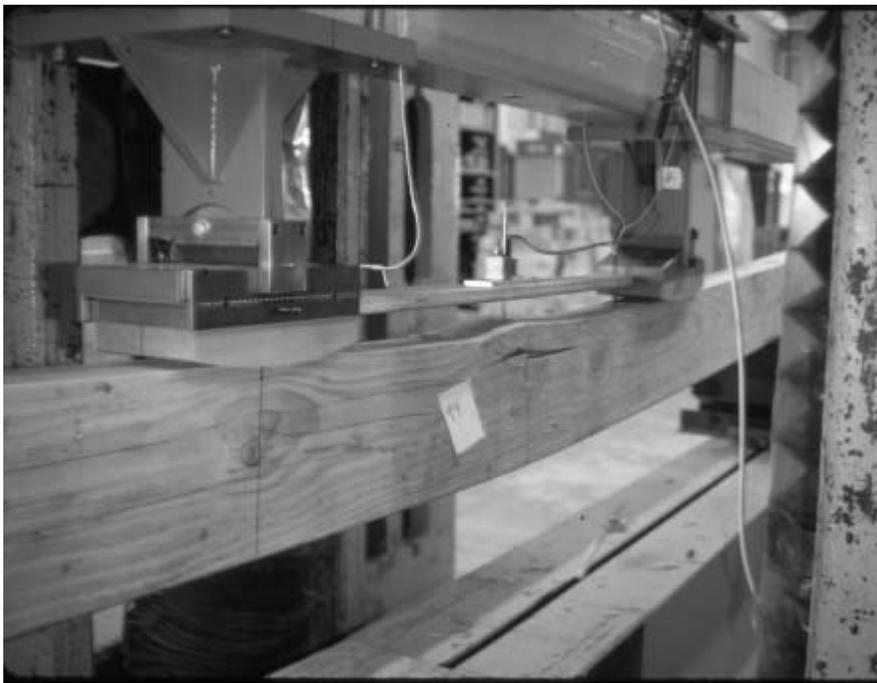
Figure 8. — Local buckling around hole in group A beam.

Failures exhibited by the lumber varied depending on the location and size of the drilled hole. **Table 3** indicates the type and frequency of failures for the beam groups. If the hole was on the compression side of the beam (Groups A and H), local buckling most often occurred above the hole (**Fig. 8**), typically followed by a load increase and general tension-side failure in the beam. When the drilled hole was on the tension side of the beam, failure typically initiated at the hole (Groups B, D, and I). Group B lumber (1 in. (25.4mm) hole, 1 in. (25.4 mm) from tension edge) exhibited a variety of failures including tension at the hole, normal wood tension, compression failure, and slope-of-grain failure. Interestingly, Group E lumber (half cir-

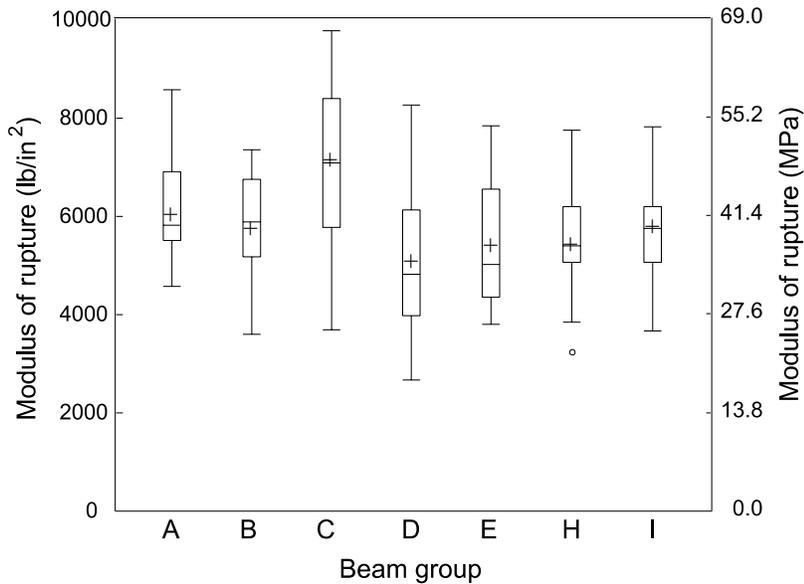
Figure 9. — Box plot of MOR data.

lated and used for part of the analysis. At the mean level, the control (group C) lumber exhibited the highest MOR, with all other groups exhibiting lower strengths (71.5% to 86.8% of control) (Table 4, Fig. 9). The weakest beam group was group D, a 1-inch (25.4-mm) hole 1/4 inch (6 mm) from the tension face, suggesting that holes closer to the tension edge reduce strength more than those further away. An analysis of vari-

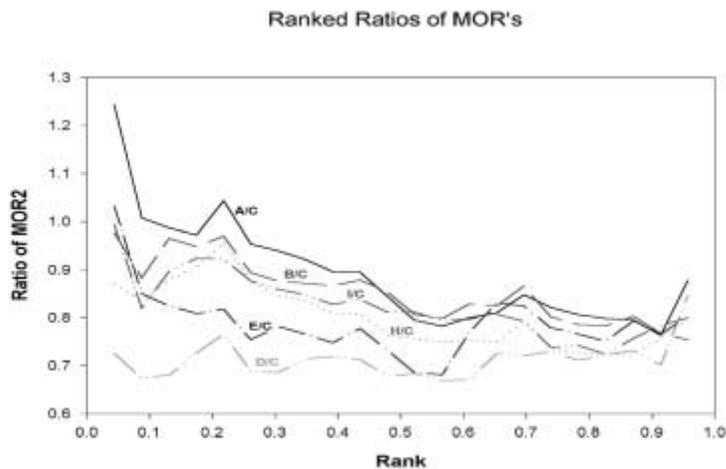
Figure 10. — Ranked ratios of MOR values.

The MOR values of each group were ranked to determine how the whole distribution compared to the control group (Fig. 10). To generate Figure 10, the MOR values of each group were ranked highest to lowest. The MOR of each group (ranked 1 to 22) was divided by the group C MOR values (ranked 1 to 22). As shown in Figure 10, all ratios of ranked MOR values that were less than 1.00 indicate lumber with strengths lower than that of the control. Overall, this figure indicates that with the exception of a few specimens at the lower end of the distributions, all specimens with holes were weaker than the control group of the same rank (in the worst case, strength was about 70% that of the control).
