Remilling of salvaged wood siding coated with lead-based paint. Part I. Lead exposure

Forest Prod. J. 55(7/8):76-80.

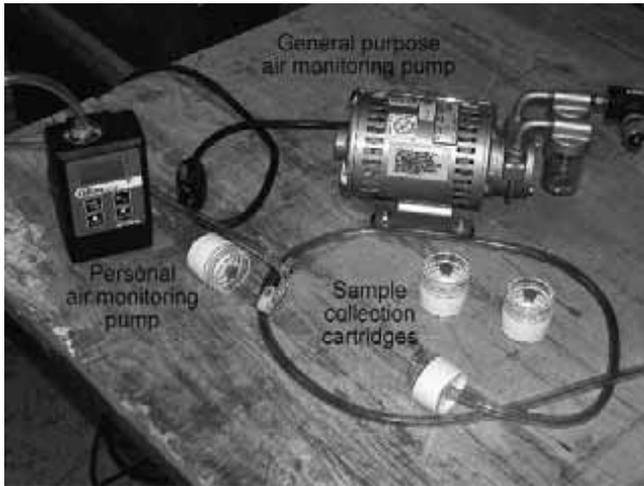
Figure 1. — Air monitoring pumps.

Air was sampled to determine if the woodworking operations produced unacceptable levels of airborne lead. Personnel performing specific milling operations were fitted with personal air monitoring pumps that operated continuously while the specific operations were performed. A constant volume of air was moved through the pump (2.0 L/min) and the time was recorded (Fig. 1).

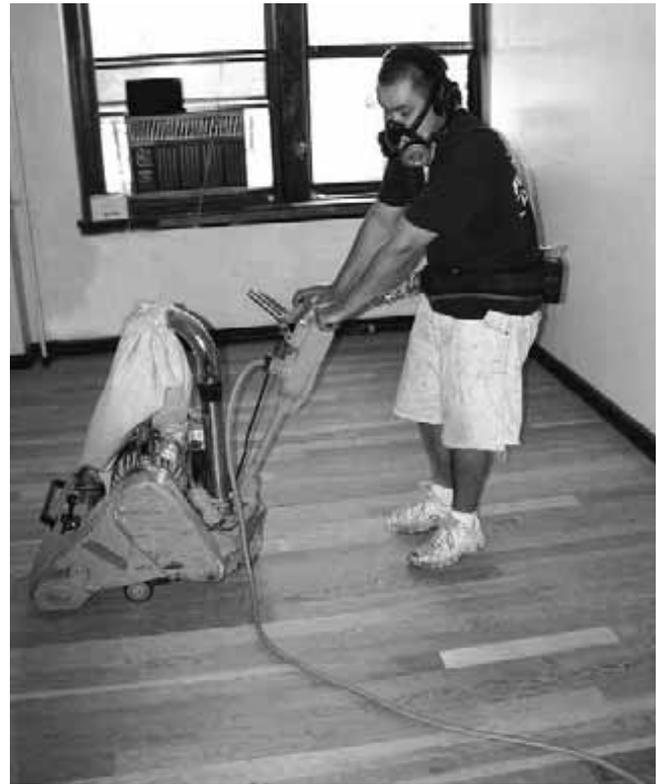
Figure 2. — Sanding of installed flooring. Note air monitoring pump on operator.

A portion of the T&G flooring produced in this study was installed in a 3.3- by 4.0-m office at FPL. After installation, a local wood floor finishing contractor was hired to sand the floor. The operator of the sanding equipment was fitted with a personal air monitoring pump in a similar fashion as were the woodshop operators (Fig. 2).
