Tips for Properly Maintaining Your Pizzi Glue System

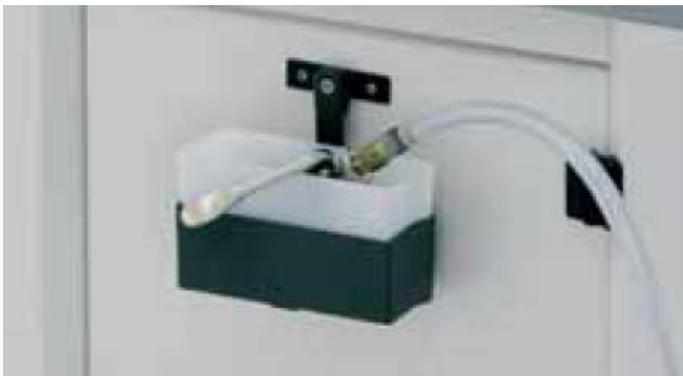
Place the nozzle in the water reservoir after use.

After each gluing period, the gun with nozzle attached should be placed back in the water reservoir that is supplied with all 9001 and 9012 tanks. This will prevent the glue from drying in the nozzle and becoming hard to clean and remove, and it will ensure your glue flows smoothly and evenly.

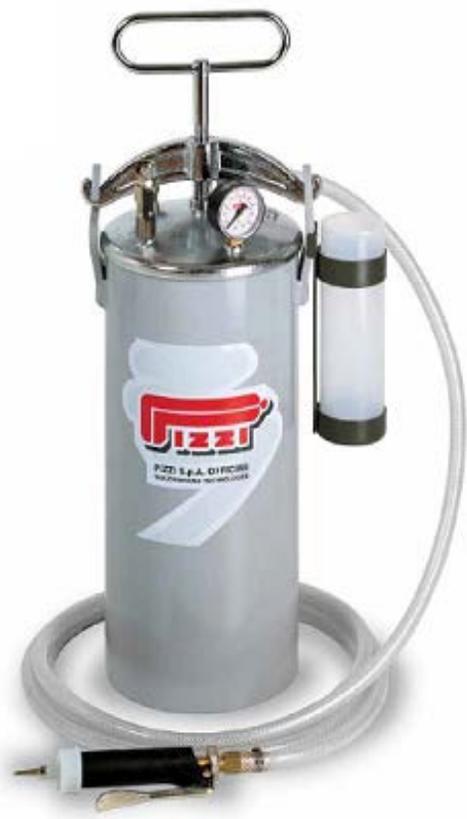
The 0044 fits all nozzles and attaches to a faucet.

All nozzles should be removed from the end of the Pizzi gun and cleaned in the sink using nozzle #0044, which is supplied with all new tanks or available for purchase. Using water, clean the gun and pay particular attention to the threaded area and brush nozzles, being sure to remove all glue.

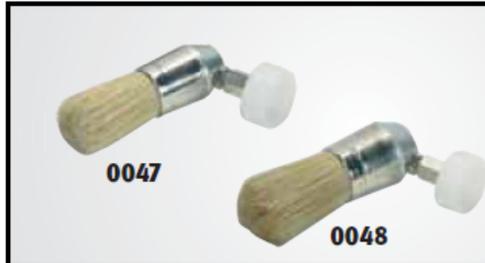
Take special care with brush nozzles.

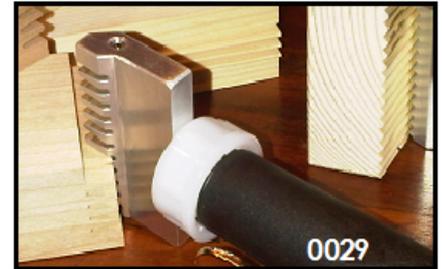
Be sure to flush the gaps in the 0029 attachment.

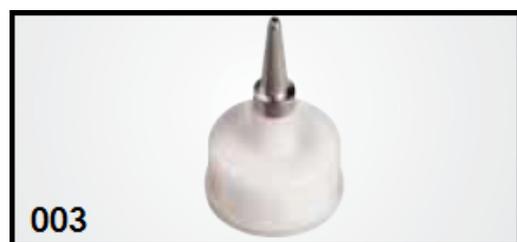
Inspect for glue buildup on the threaded end.
